An example of the calculation of the replacement cost for a single story office building

Building and Policy Details

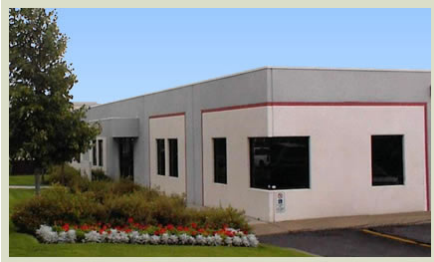
Photo:

Constructed on a flat site, 82 m by 81 m, with good street exposure & access, the building was completed during January 2000. The structure consists of a concrete slab, with foundations to a normal specification, portal steel frame, with cavity brick infill walls, suspended acoustic tile ceiling, carpeted floors except for toilet & kitchen facilities which have ceramic tile covered floors & walls. All areas are fully sprinklered and serviced by airconditioning from a central plant. Roof area is insulated and covered in metal clad colorbond. The Owner provided all inter-tenancy walls & tenants provided internal fitouts. The building is rectangular in shape having external dimensions of about 50 m (facing Heal Street) and a depth of about 66 m. The estimated gross floor area (gfa) as defined in the Building Code of Australia is about 3,300 m² and the net lettable area is about 2,950 m². Open space parking is provided for 85 cars and the fully fenced site has minimal landscaping. The all up construction cost, excluding the cost of funding and land acquisition, was \$6.75 million or \$2,045 per m² of gfa
